# **Operator Training: Booster Injection**

# Part One: Booster Injection

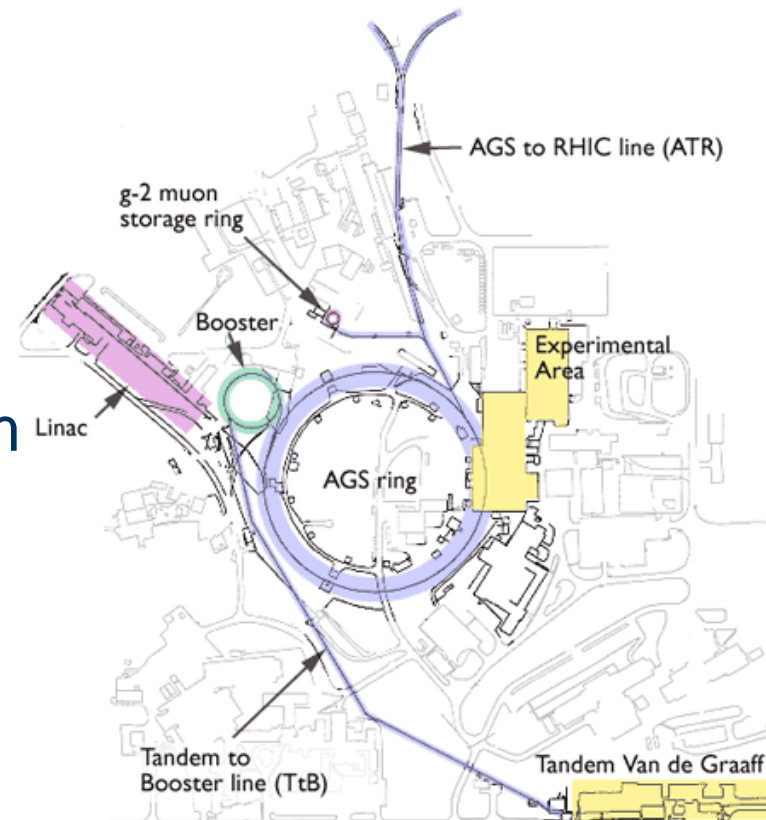
- Currently, all species of particles accelerated in the AGS must first be injected, accelerated, and extracted from the AGS Booster
- Two sources from which beam is delivered to the Booster
  - LINAC
  - Tandem Van de Graff

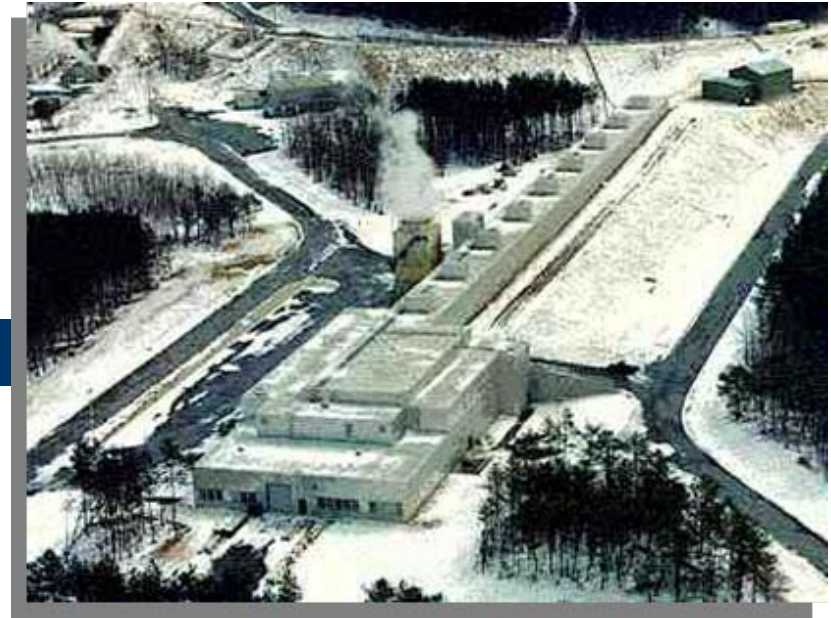
# The LINAC

- Two species of particles
  - High Intensity Proton Mode
  - Polarized Proton Mode
- Transported from source to the LINAC via LEBT
  - Low Energy Beam Transport
- LINAC accelerates protons to 200 MeV
- Transported to Booster via LTB transfer line
- Utilize stripping foil at Booster injection

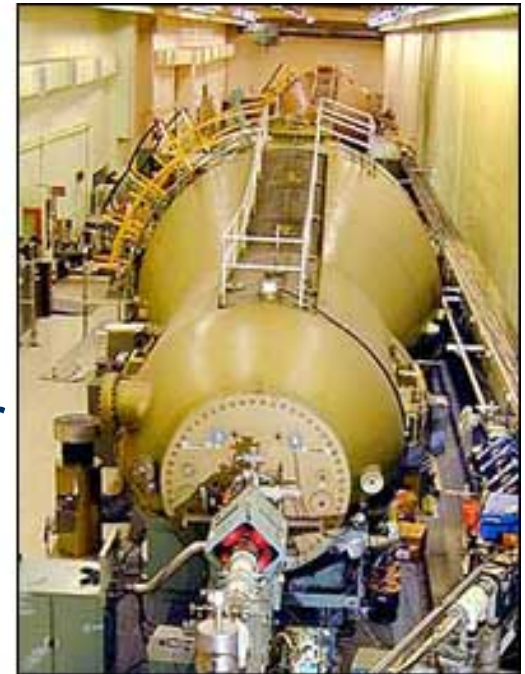
# The Tandem van de Graff

- Pre-accelerates all species of ions to be injected into Booster
- Beam is transported to Booster via TTB transport line
- Stripping foil(s) in transport line are used to attain desired charge state for injection into the Booster
- An electrostatic inflector is used to inject beam into the Booster

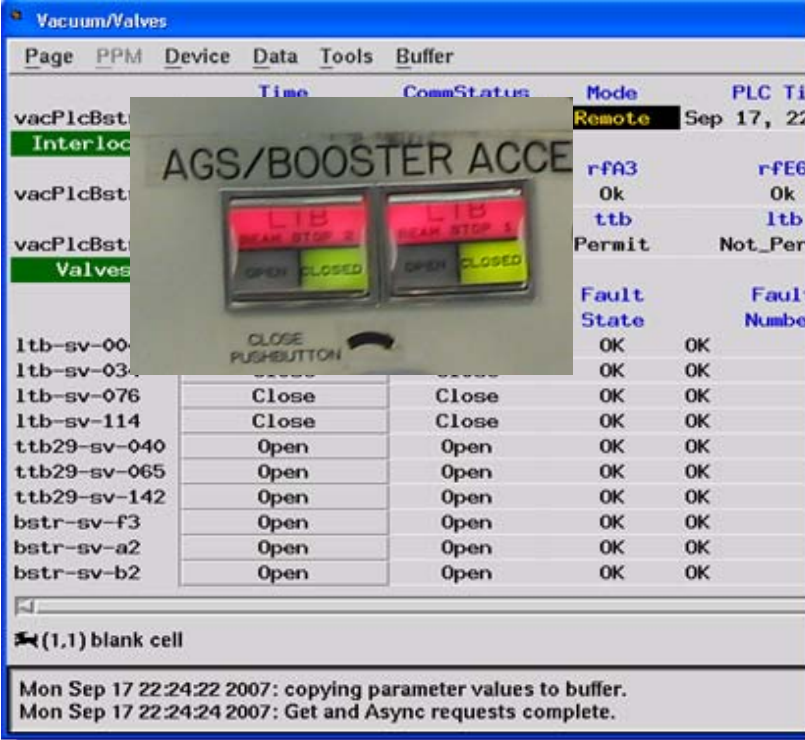
- If LTB beam stops are closed, check for interlocks or failures
  - Clear the problem and open the beam stops
- If vacuum valves in the Booster, LTB or BTA are closed, attempt to open them
  - If they open, problem is solved
  - If they do not open, check the vacuum gauges and check the vacuum.
  - Call the vacuum group for assistance.

The screenshot displays the 'Vacuum/Valves' control interface. It features a table with columns for Device, Data, Tools, Buffer, Time, CommStatus, Mode, and PLC Ti. The table lists various vacuum valves and their current states (Open/Closed) and fault status (OK/Not\_Permit).

Below the table, there is a physical control panel for the LTB beam stops. It features two red emergency stop buttons labeled 'LTB BEAM STOP 2' and 'LTB BEAM STOP 1'. Each button has 'OPEN' and 'CLOSED' indicators. Below the buttons is a 'CLOSE PUSHBUTTON'.

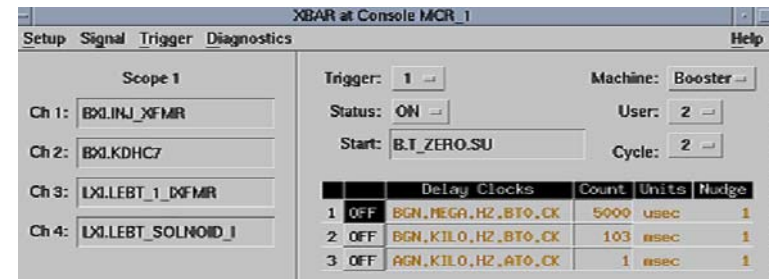
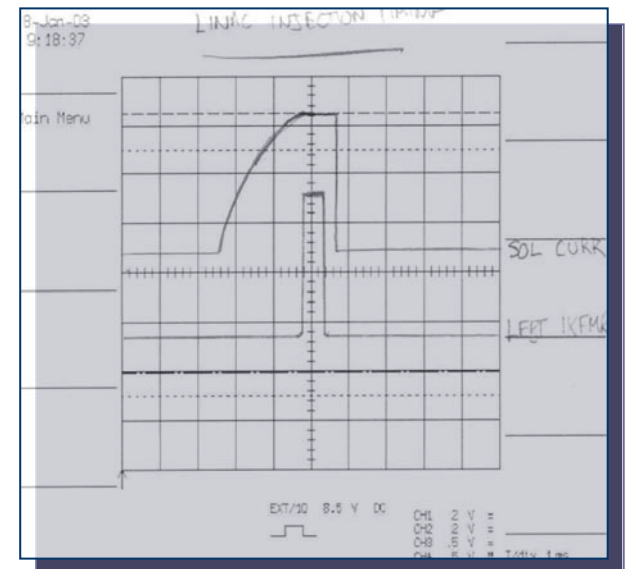
# LEBT Timing

- Solenoids in the Low Energy Beam Transport (LEBT) are pulsed
  - Timing of pulse must coincide with the beam
  - Wrong timing will cause an audio chirp alarm
  - Connect the signals LEBT\_1\_IXFMR and LEBT\_SOLENOID\_I to a scope using XBAR
  - Flattop of quad pulse and beam current pulse should be aligned

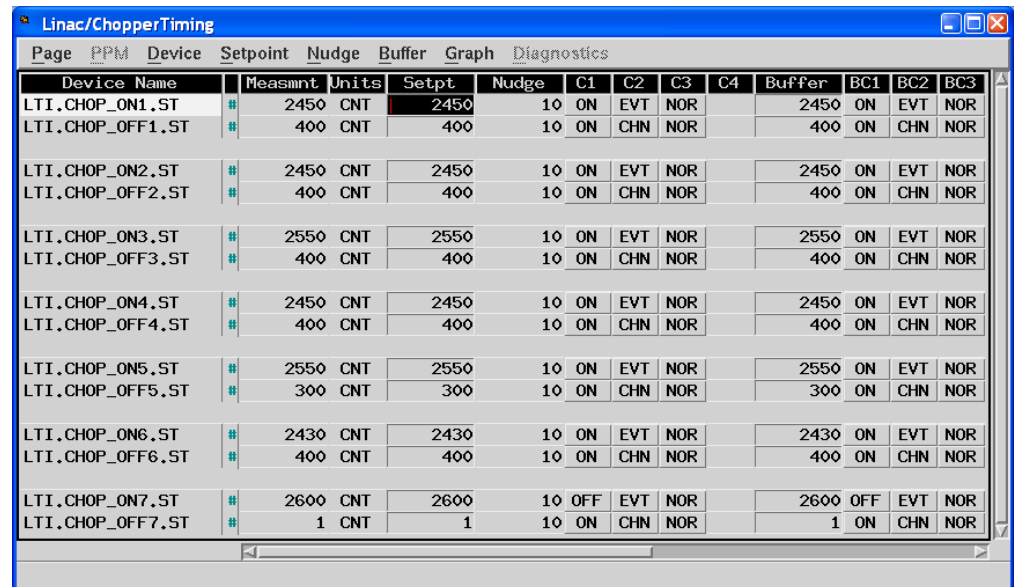
- Check that the audio alarm is not acknowledged
- Check source output
  - Look at TV channel for LINAC source
- Check that the slow chopper is working and on

The screenshot shows a software window titled "Linac/ChopperTiming" with a menu bar (Page, PPM, Device, Setpoint, Nudge, Buffer, Graph, Diagnostics) and a table of device parameters. The table has columns for Device Name, Measmnt, Units, Setpt, Nudge, C1, C2, C3, C4, Buffer, BC1, BC2, and BC3. The data is organized into groups for LTI.CHOP\_ON1.ST through LTI.CHOP\_ON7.ST, each with a corresponding LTI.CHOP\_OFFX.ST row.

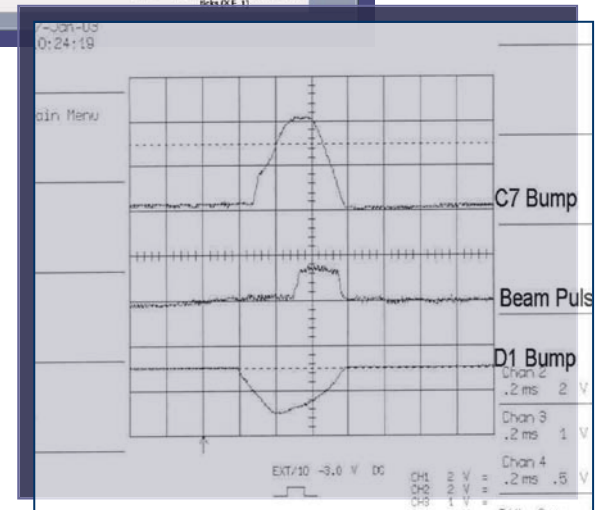
# No Circulation in Booster

- Turn the RF off
- Are injection bumps working properly?

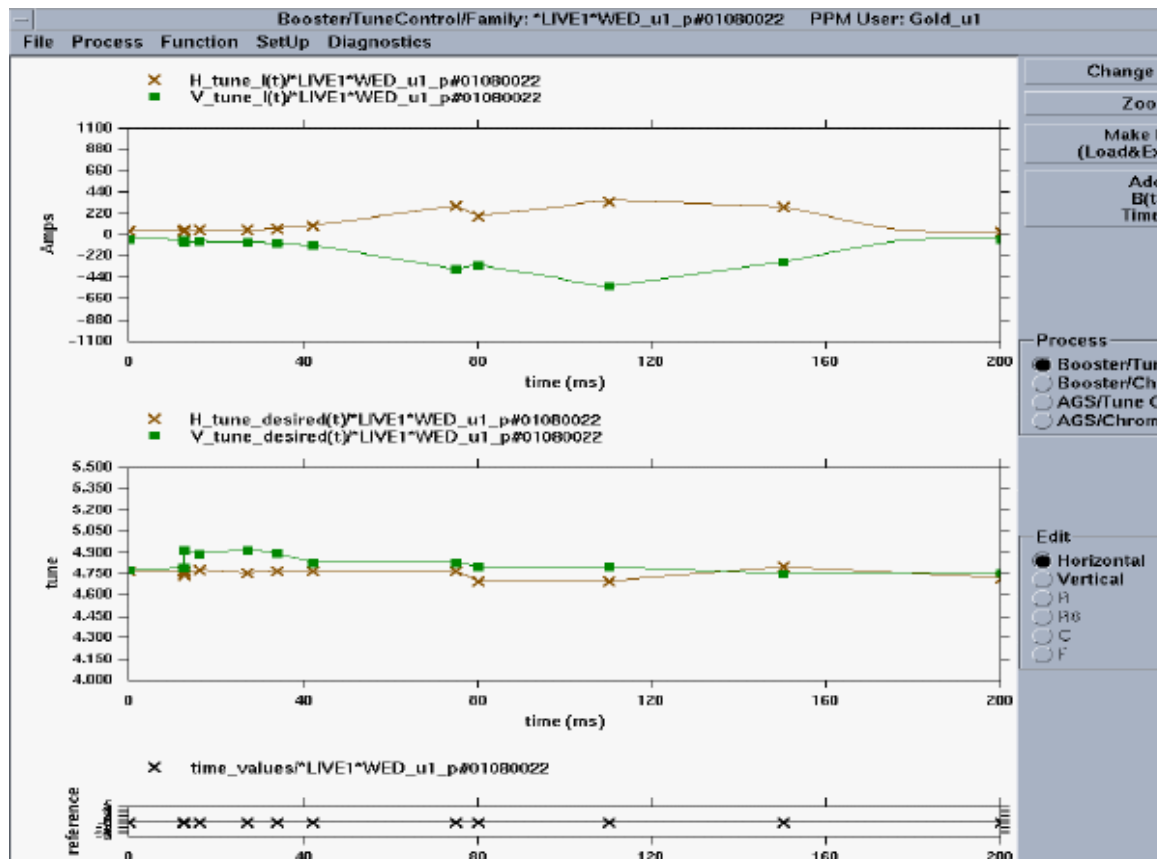
# Tune Control

- Often when running high intensity protons, Booster is set up such that the vertical tune is very close to 5, an integer resonance capable of causing rapid beam loss
- Lowering the tune by .05 units will allow beam survival
- The tune can then be optimized after beam is re-established

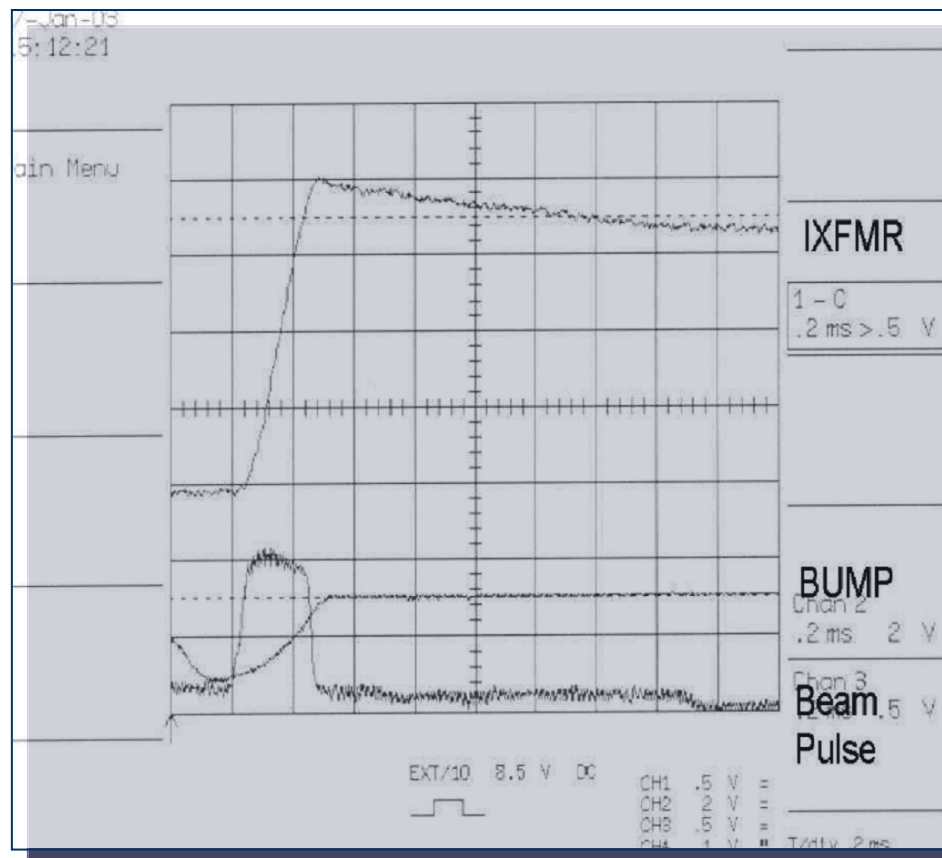
# Injection Bump

- Injection bumps and beam pulse must be properly aligned to allow injection.
- The following illustrates proper timing for heavy ion operation
- Note that the beam pulse is aligned with the collapsing edge of the bump
